# Impacts of Sulfur Loading Following Alum Treatment of Waughop Lake, Pierce County, Washington

Colin Glaze and Jeffrey Tepper

Geology Department, University of Puget Sound, Tacoma, WA

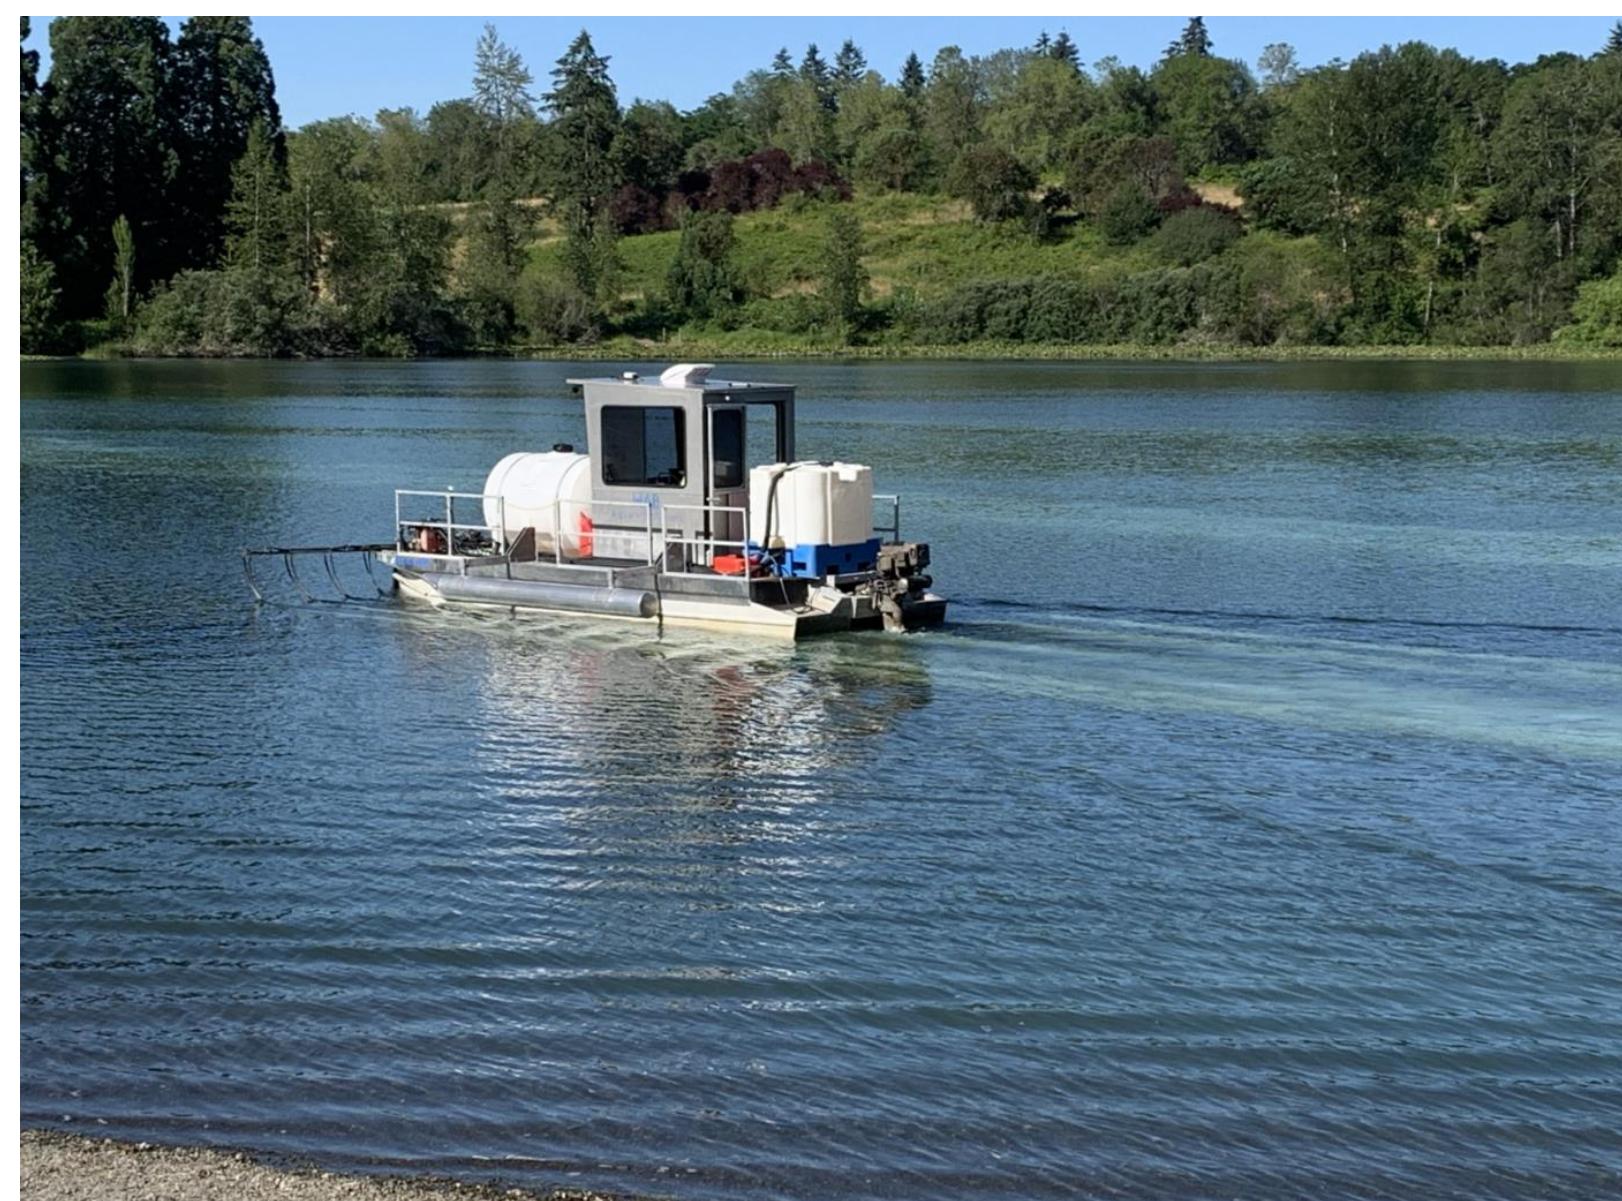
Figure 1. Alum application process at Waughop Lake. The barge drives around the lake spraying alum and buffer together.

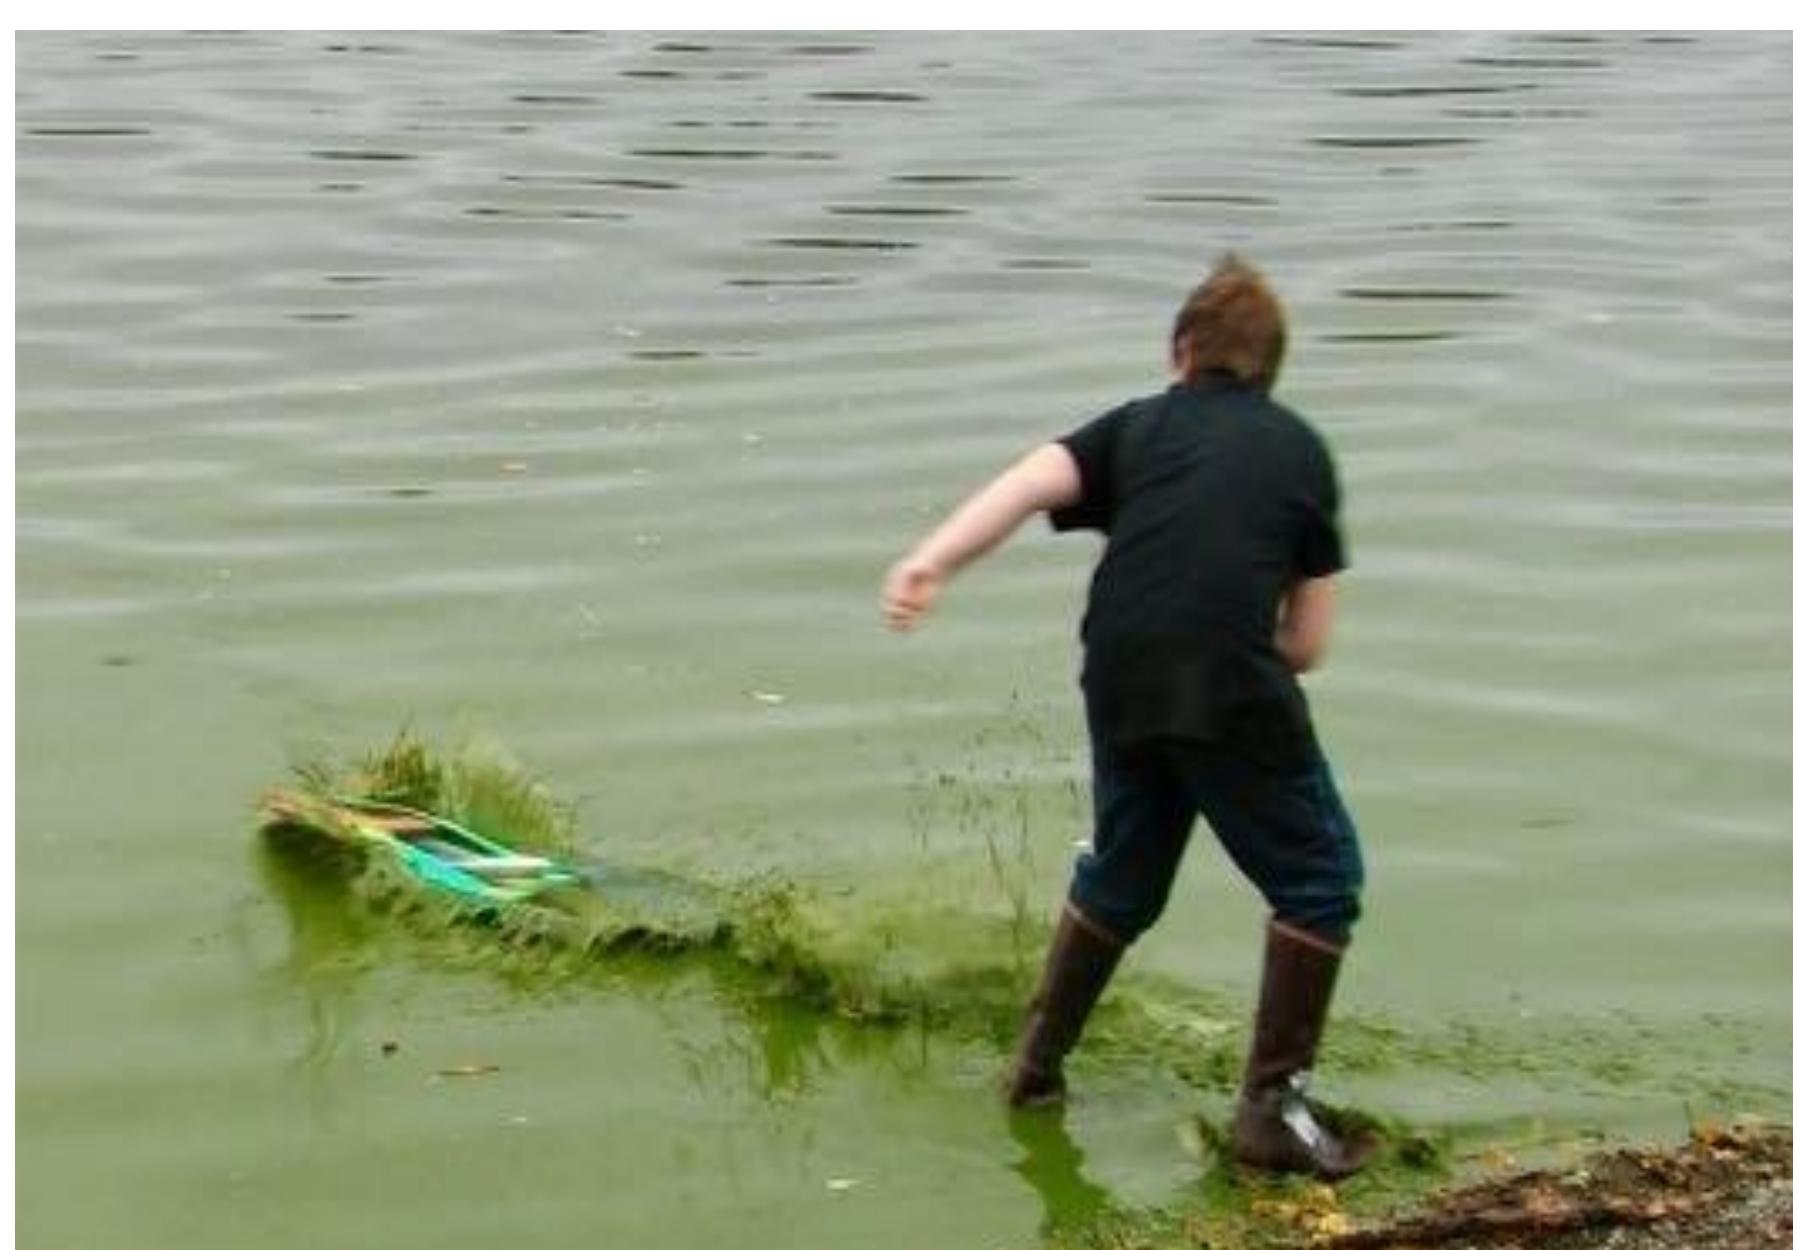
Figure 3. Photo of Waughop Lake showing hazardous green algae.
