Lake Lawrence Cyanobacteria Management Plan Mid-Year Monitoring Update

May 5, 2025; 6:30-7:30 pm

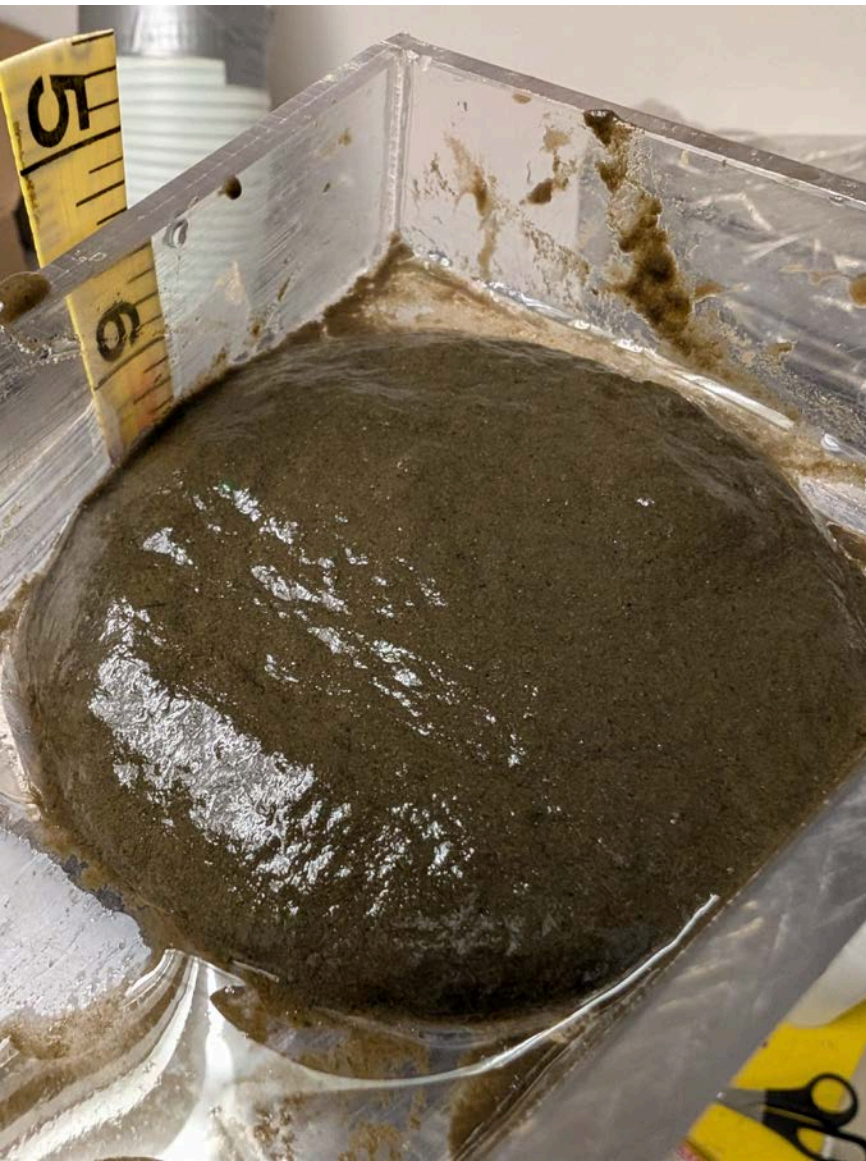
Near surface

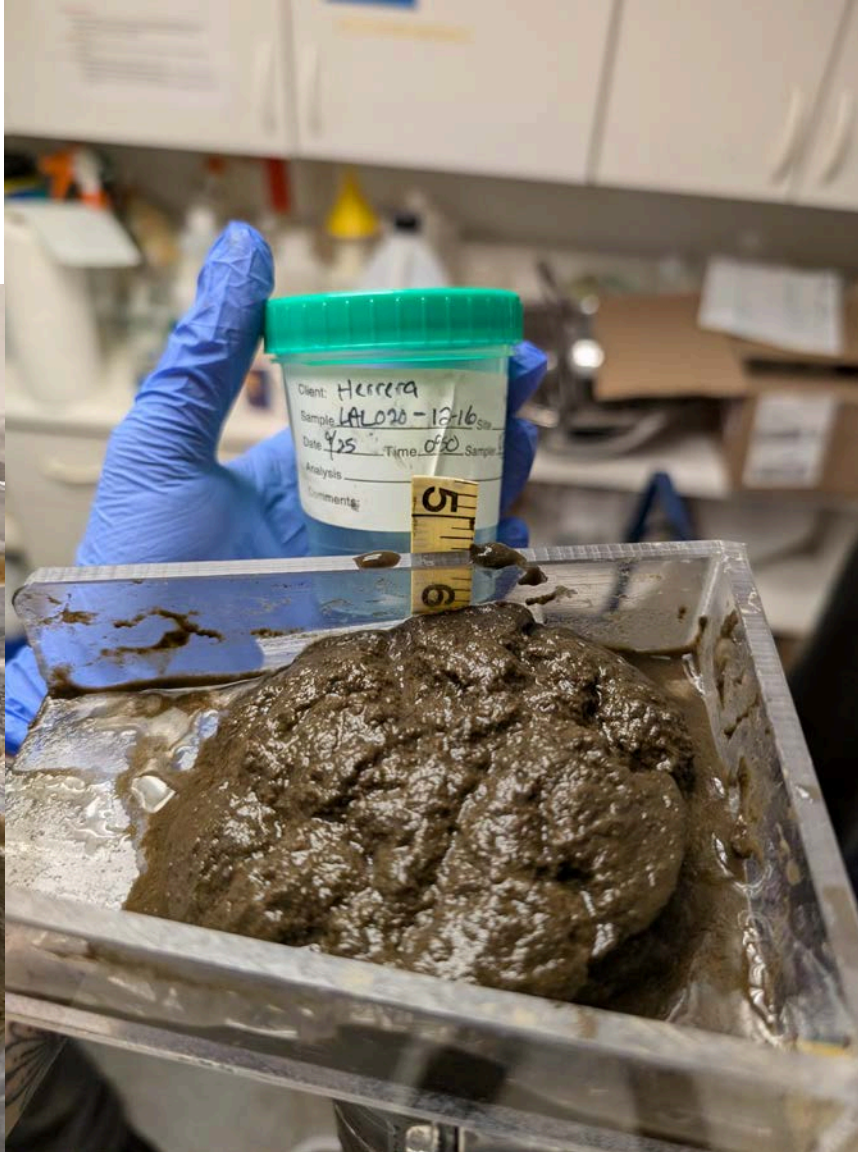
12-16 cm beneath

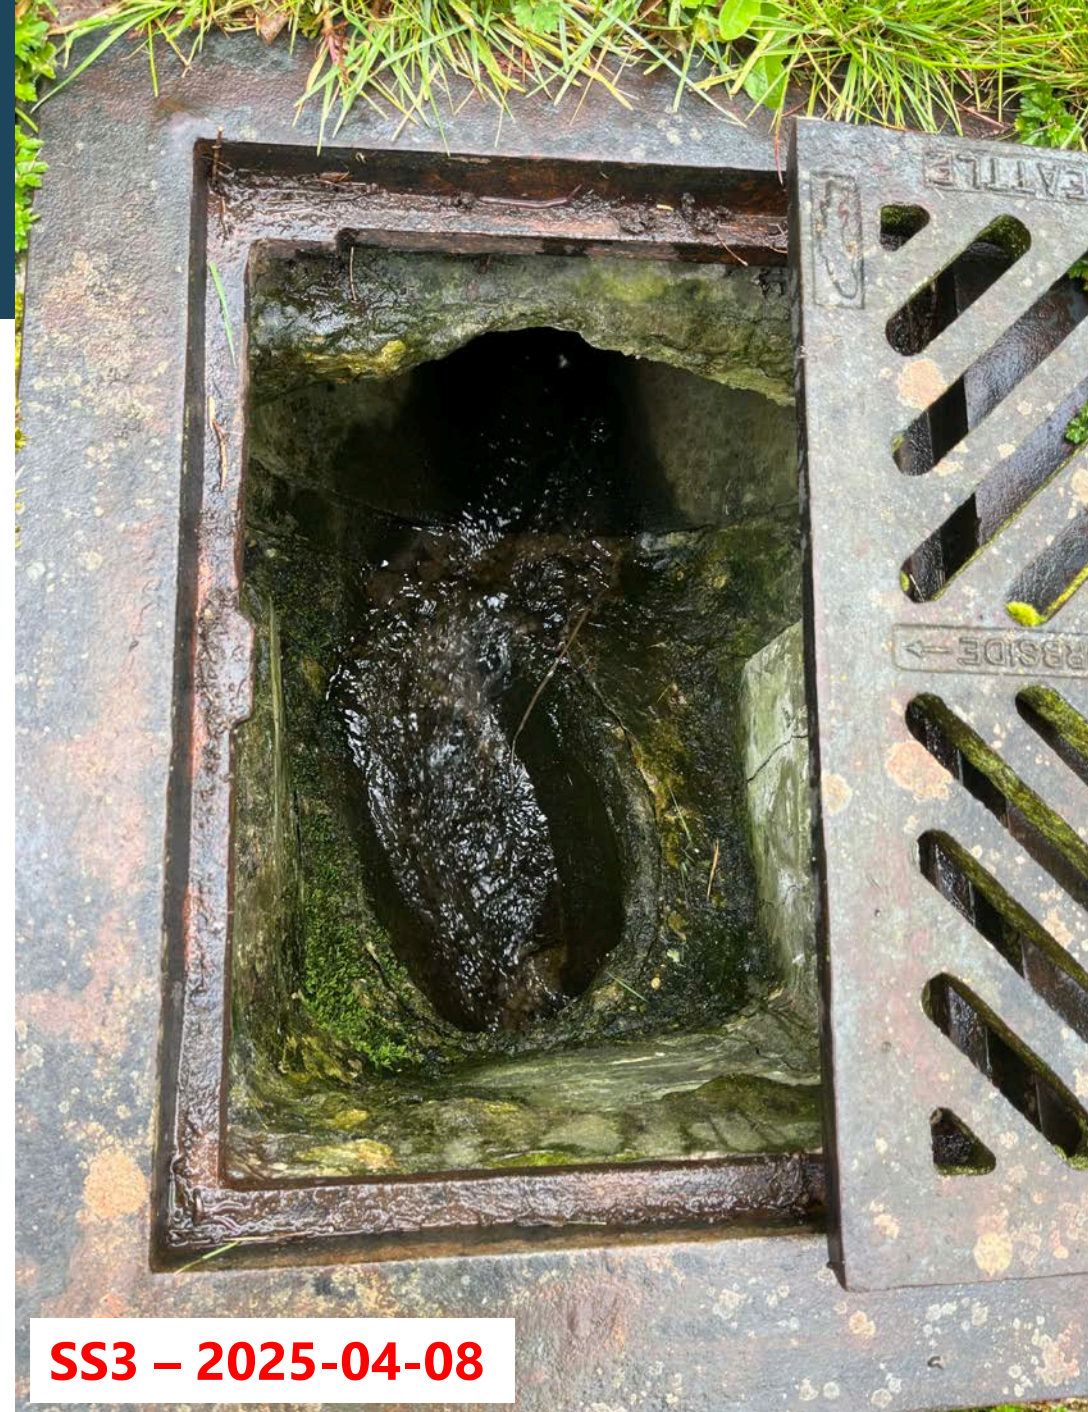
SS3 - 2025-04-08

Site	2025-02-25	2025-04-08
SS1	549 ug/L	No flow
SS2	155 ug/L	102 ug/L
SS3	147 ug/L	235 ug/L
DITCH-IN (appears to represent lake)	19 ug/L	44 ug/L
KCM 1991		
Groundwater	63 ug/L	
Overland	Forested: 25 ug/L Residential/Agriculture: 324 ug/L Volume-weighted: 192 ug/L (literature values)
