Lake Lawrence

Phase I Restoration Analysis

Final Report
December 1991

Kramer, Chin & Mayo, Inc.
1917 First Avenue, Seattle, WA 98101-1027

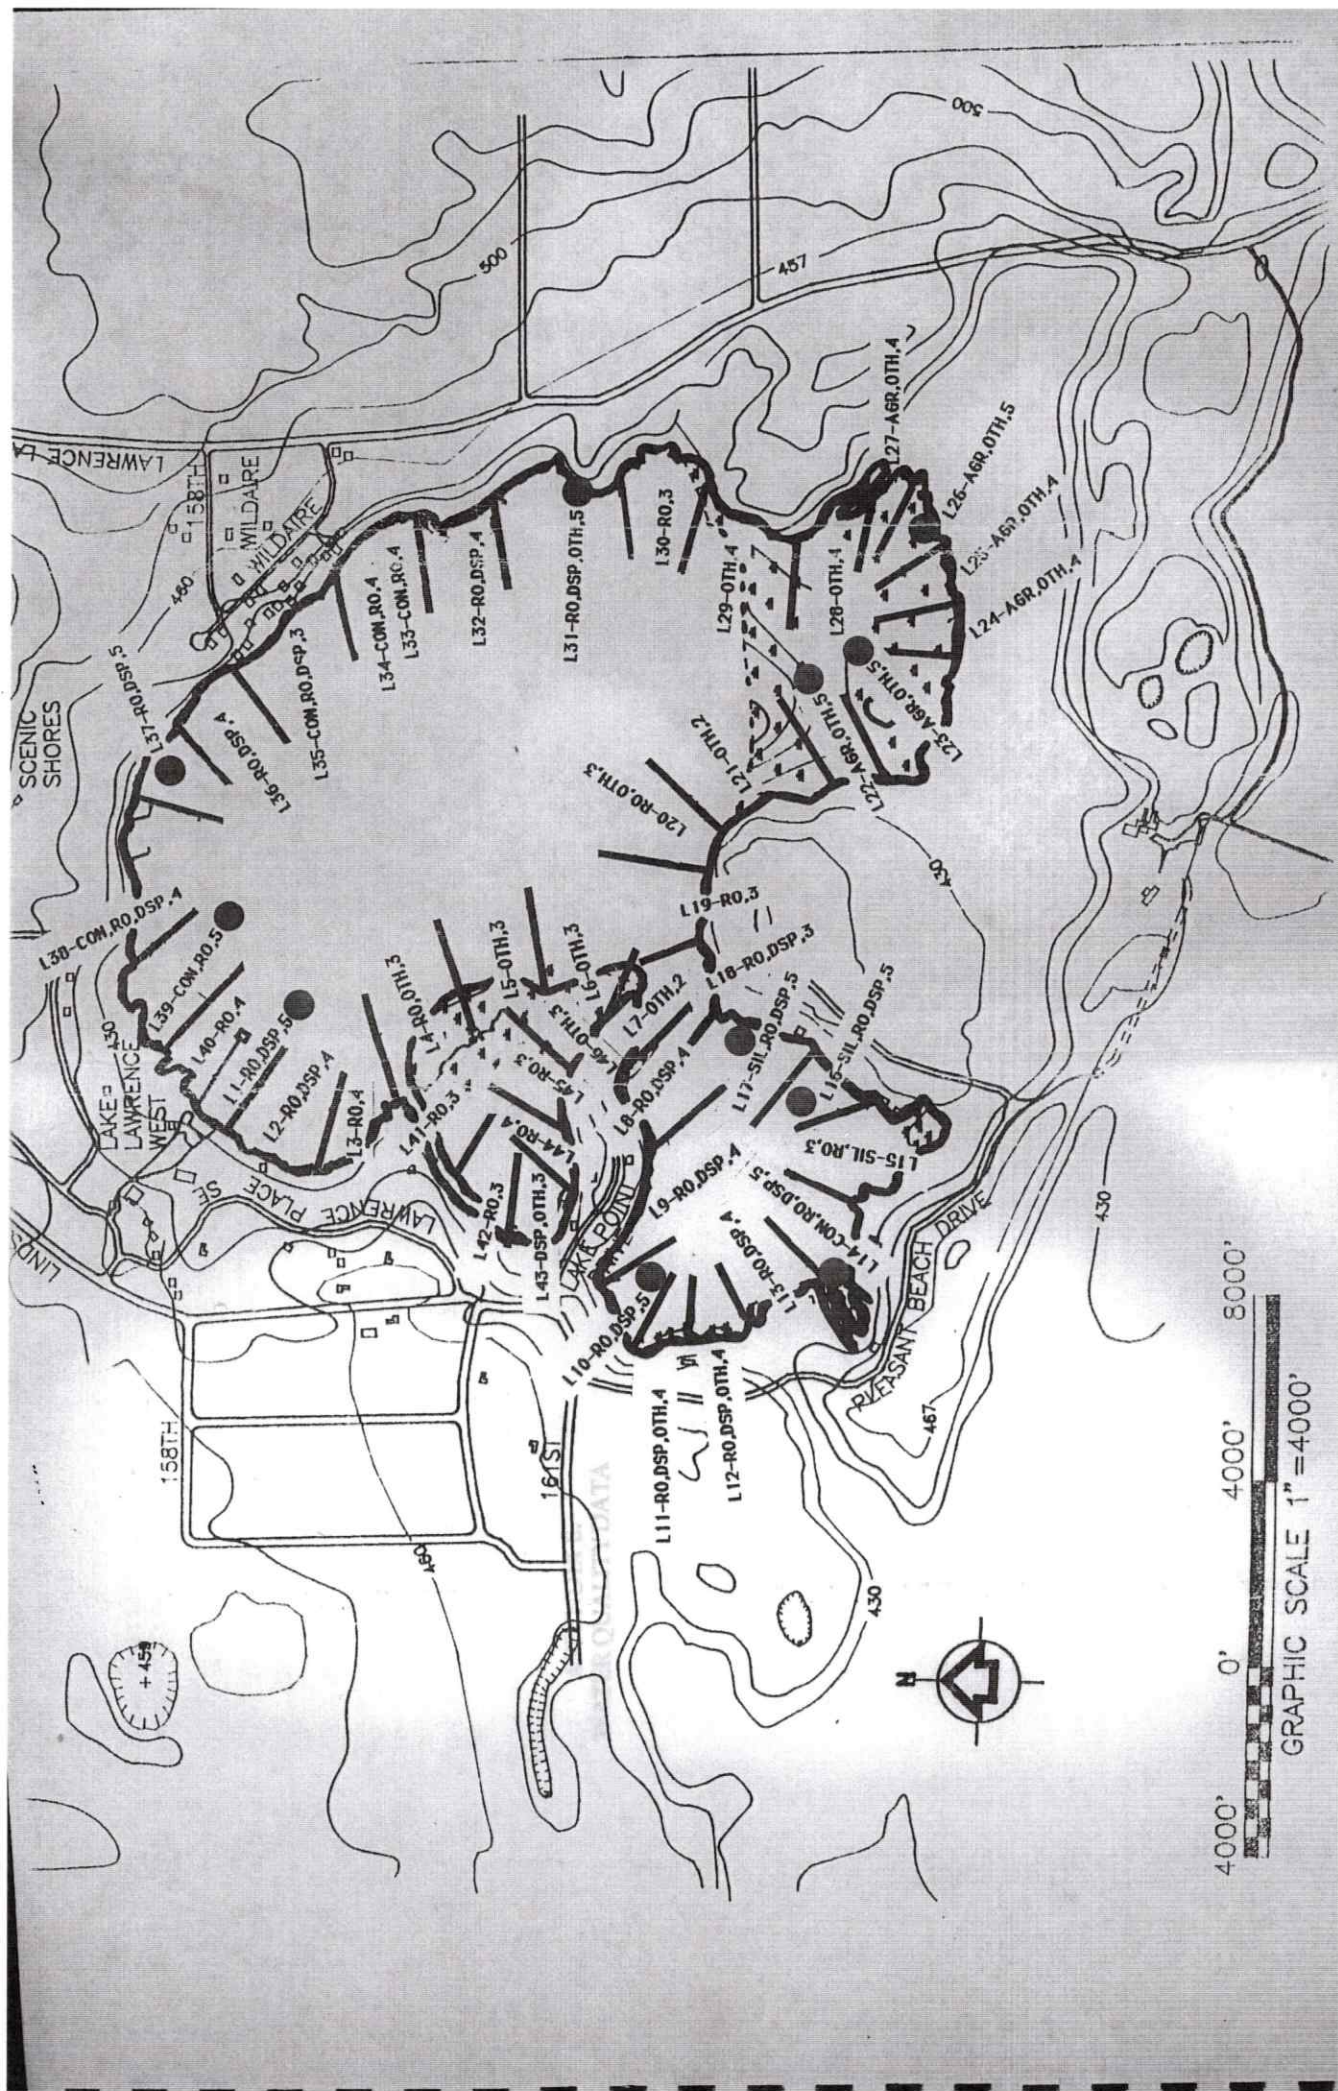
LAKE LAWRENCE AERIAL SHORELINE ANALYSIS

The entire set of imagery was reproduced in 35 mm slide format and is included as an appendix to this report. Each image is numbered to correspond to an image position on the map in the results section. This map shows each image position as well as provides the rating and pollution input information. The code is: Map Position Number-Pollution Sources (see codes above), Impact Rating (see codes above). An example would be: L17,SIL,RO,DSP,5. This would mean that for

The rating system provides a level of problem assessment that can be used to prioritize critical sites for further inspection and sampling. Ratings of 1 or 2 indicate minor or no observed conditions of pollution impact to the lake. A rank of 3 is a mid range rating indicating that suspect conditions are apparent from examination of the imagery. Ratings of 4 and 5 indicate significant problems are implicated at that position that warrant further investigation.
